# Manhole Inspection Summary

Manhole # S33CC\_019MH

Insp Date: **8/29/08 12:06 PM**

**Location** Address: **W CHASE ST**

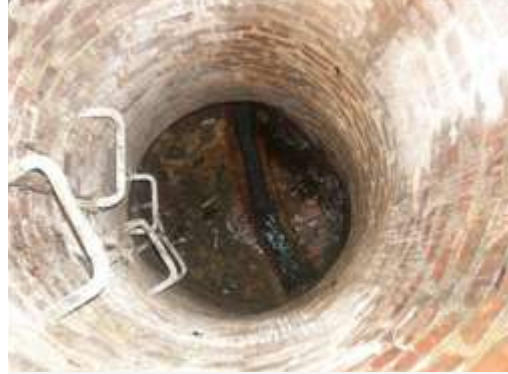
Top View

Evidence of surcharge - Bench debris.

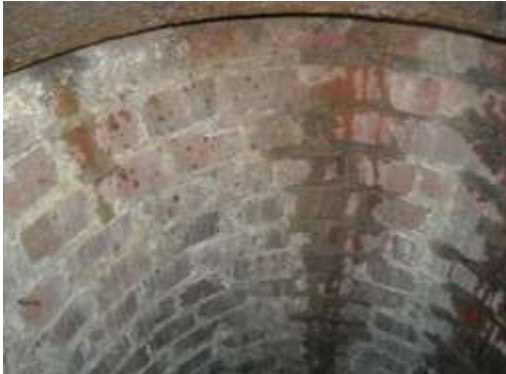
Defect

**Frame** Offset: **2.5** (in.) Condition: ☐ Sound ☐ Cracked ☒ **Leaks**

**Corbel** Material: **Brick** ☐ Parged Type: **Concentric/Eccentric**  
Condition: ☐ Sound ☐ Cracked ☐ Root Intrusion ☐ Loose Brick ☒ **Deteriorated**  
Infiltration: ☐ None ☒ **Joint** ☐ Cracks ☐ Mortar ☐ Roots ☐ Wall

Frame leaks. Corbel infiltration.

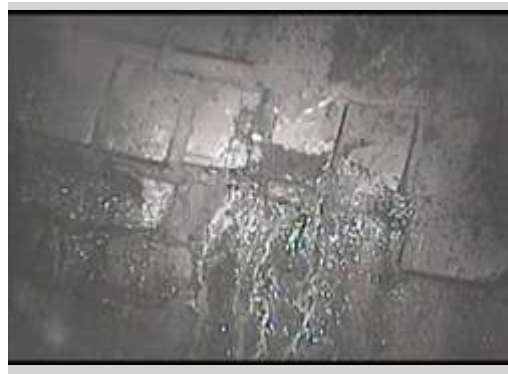
Defect

Comments **The cover was stuck on the 1st visit. There is Active infiltration in this MH.**

**Barrel** Material: **Brick** ☐ Parged  
Shape: **Circular** Diameter: **48** (in.) Length: (in.)  
Condition: ☒ Sound ☐ Cracked ☐ Root Intrusion ☐ Loose Brick ☐ Deteriorated  
Infiltration: ☐ None ☐ Joint ☐ Cracks ☒ **Mortar** ☐ Roots ☒ **Wall**

Barrel infiltration (Active).

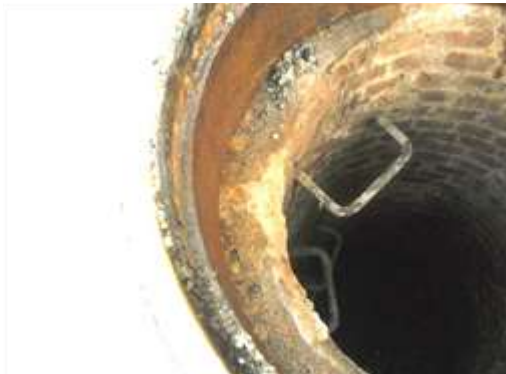
Defect

Frame leaks. Frame offset. Corbel and Barrel infiltration.

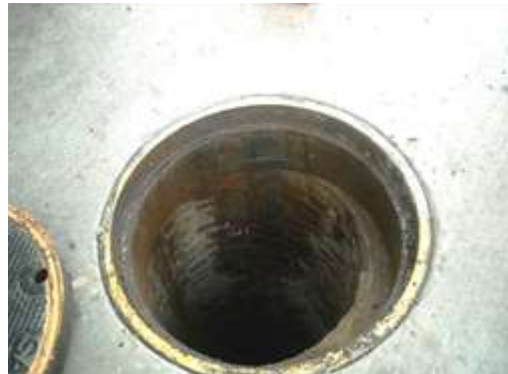
Defect

INFLOW EVIDENCE FROM SHEETING

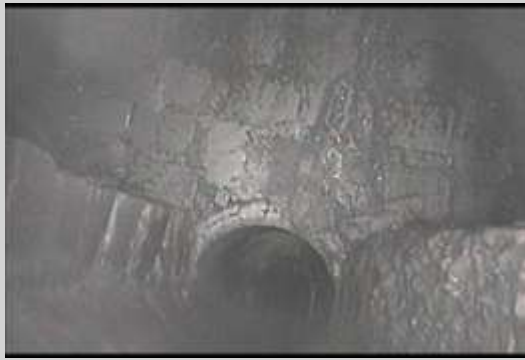
### 8 in. Circular Gravity Sewer Pipe Out @ 12 O'Clock

Pipe Material: **Clay** ☐ Pipe Lined

Invert Depth: **12.64** (ft.) Flow Characteristics: **Slow**

Infiltration: **None** Pipe Seal Cond: **Unknown**

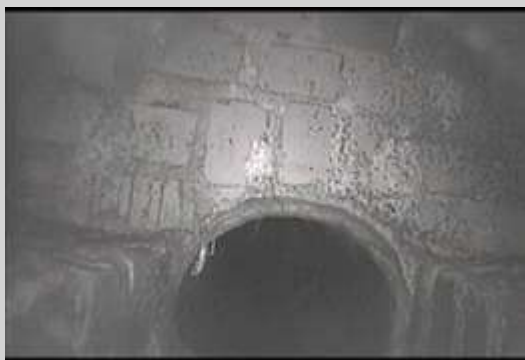
### 8 in. Circular Gravity Sewer Pipe In @ 5 O'Clock

Pipe Material: **Clay** ☐ Pipe Lined

Invert Depth: **12.10** (ft.) Flow Characteristics: **Slow**

Infiltration: **Evidence** Pipe Seal Cond: **Unknown**
